## Case 246 : Narrative

Case Vehicle (A): 1999 Ford	Vehicle (B): 1997 Ford	Vehicle (C): 1992 Mercury
Type: Taurus SE, 4-door sedan	Type: F150 XLT, 4x2 pickup	Type: Grand Marquis LS, 4-door sedan
Driver: 50-year-old female	Driver: Unknown	Driver: Unknown
CDC: 12-FDEW-3, 03-RFEW-2	CDC: 12-FDEW-3, 99-0000-0, 03-RBEW-2	CDC: 12-FYEW-2, 99-0000-0

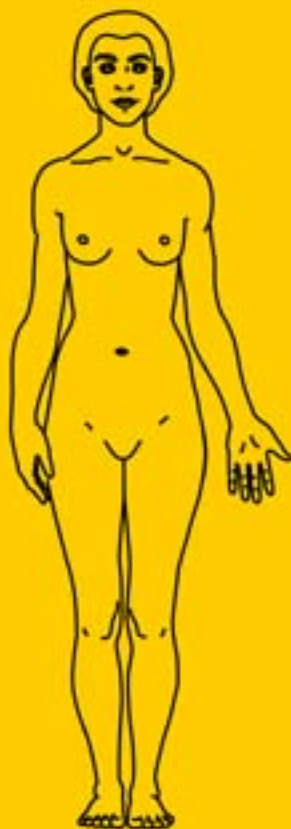
Fracture, right patella  
(2)

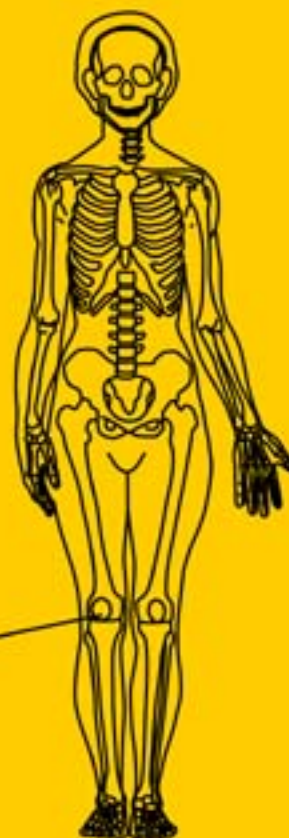
Lacerations, right forehead - 4-cm long, full-thickness joining  
an 11-cm laceration with a Y-shape complex  
(2)

Laceration, left temple - 4-cm long  
full-thickness  
(1)

Small bowel deserosalization  
(2)

Tear, small bowel  
(2)

Contusions, across  
lower abdomen  
(1)

Complete disruption of the  
anterior wall musculature  
(2)

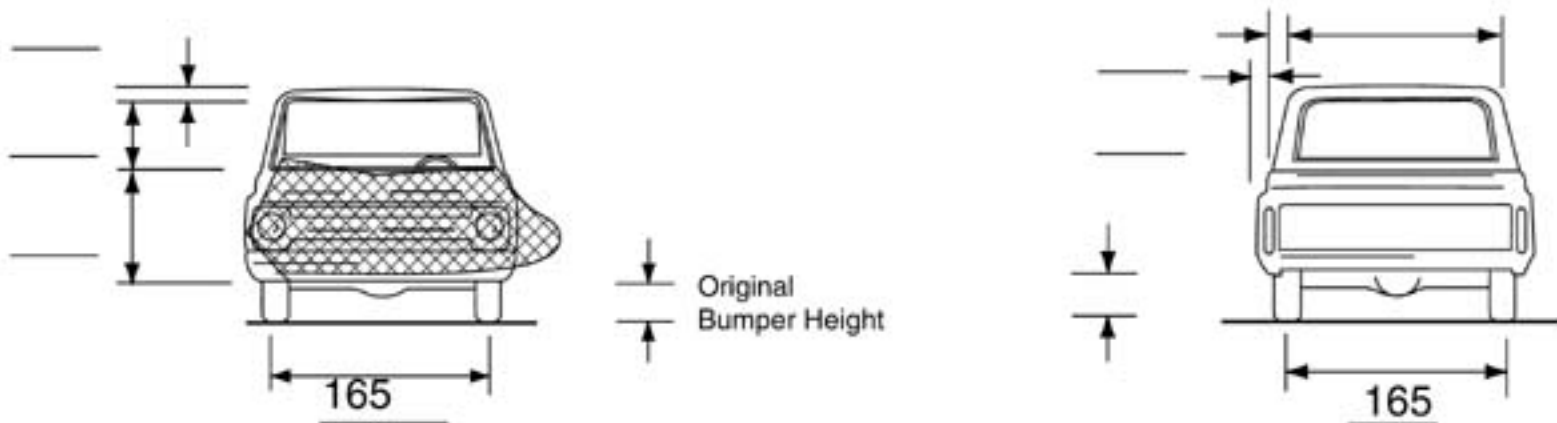
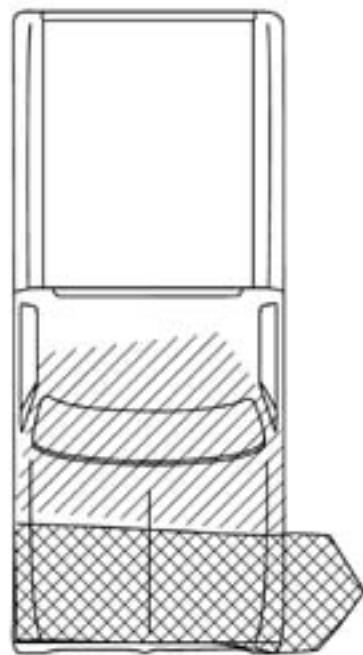
180 cm direct damage  
57 cm max crush  
impact # 1 and #2

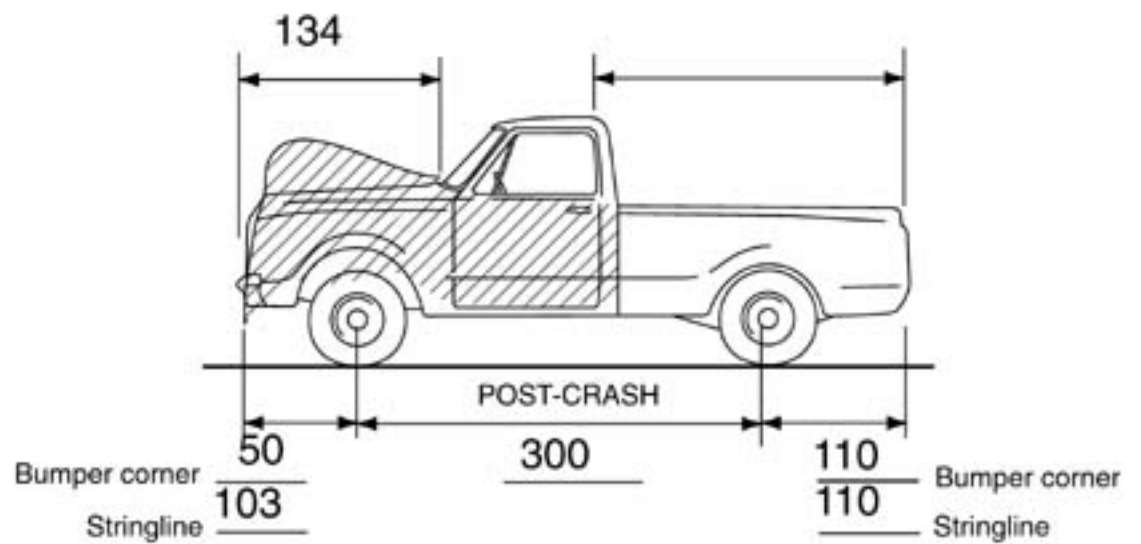
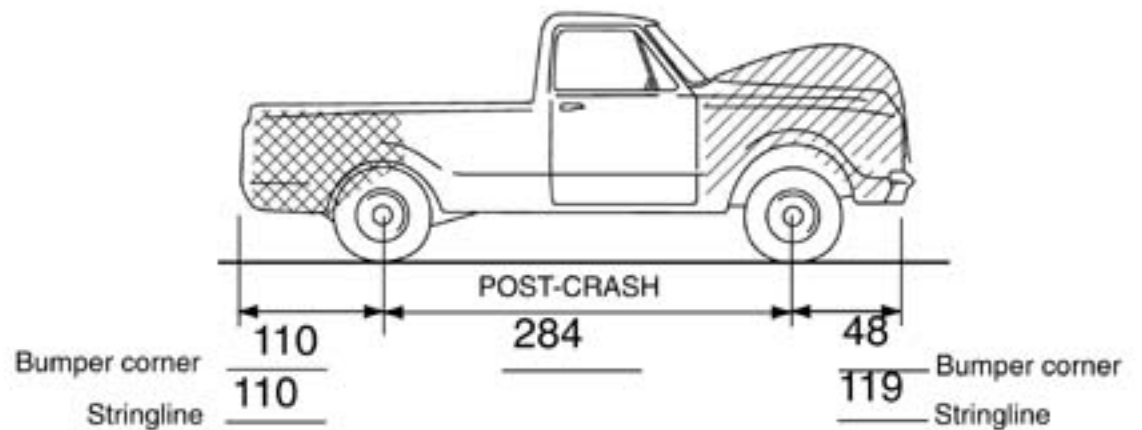
161 cm direct damage  
26 cm max crush  
Impact #3

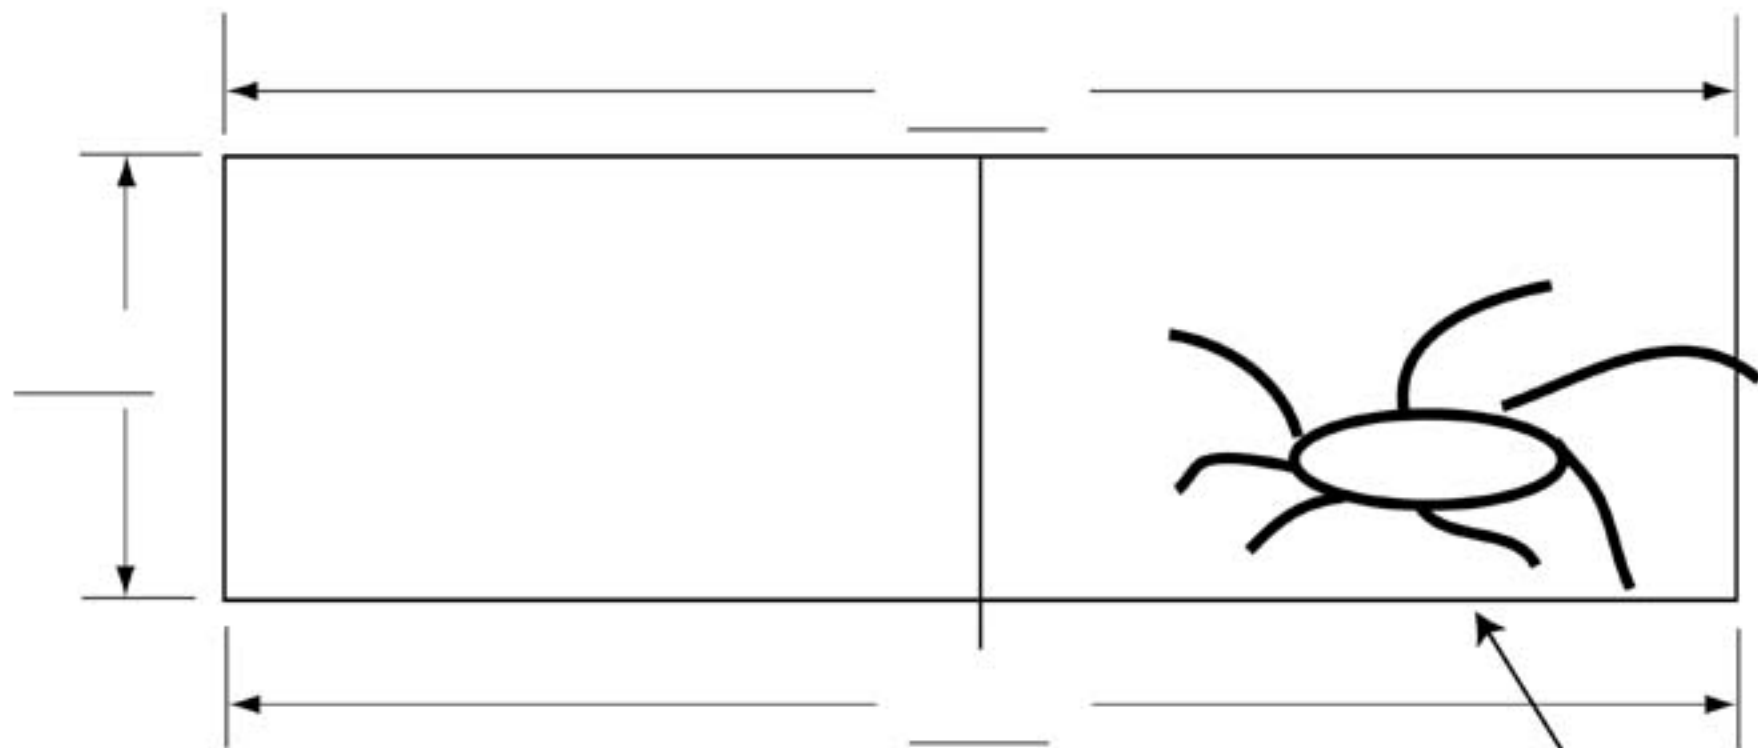
air bag cover  
contact

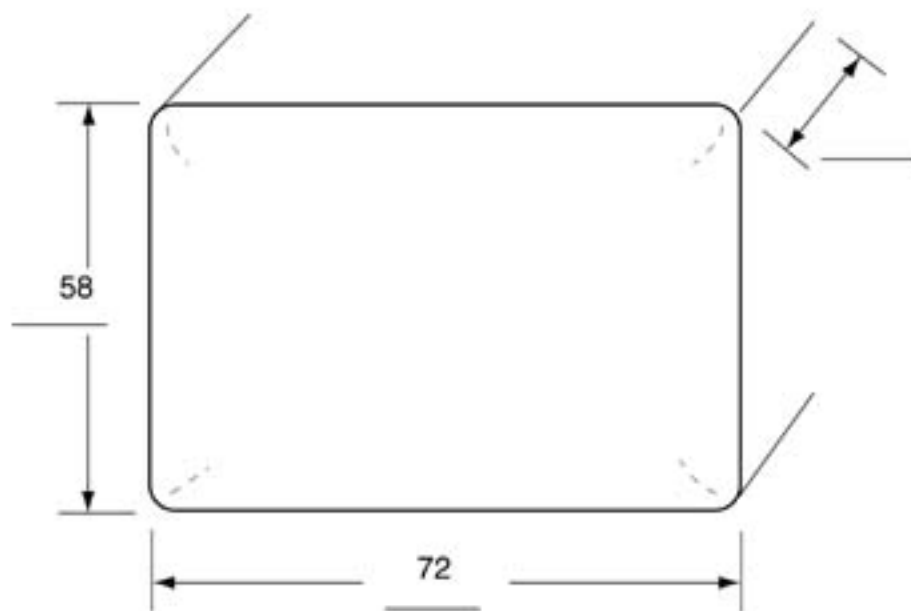
### Passenger Airbag

cover contacted and  
cracked the windshield
